The Bellows Bottom Line

Practical advice on expansion joints

This month - **When weld repairs work - and we don't know why**

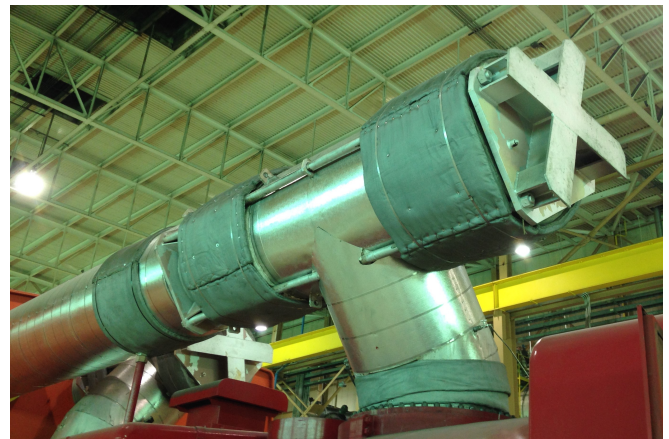
Got a call years ago from a power plant that kept shutting down to weld repair a bellows attachment weld on their old Westinghouse steam cross-over expansion joint – their weld repairs held up less than a year.

It was a Westinghouse unit that looked like this

The original cracking could be explained by poor fit-up combined with excessive vibration – we just don't know.

“*Try using Inco 82 tig wire this time*”, I told them.

We do know that Inco 82 fixed it, and then we all noted it, and then moved on.
