Going *back* to metal expansion joints in the hot air pulverizer ducting

August 2009 – A coal fired power plant on the east coast had a coal duct explosion that ripped through their fabric expansion joint and continued to burn when exposed to the atmosphere.

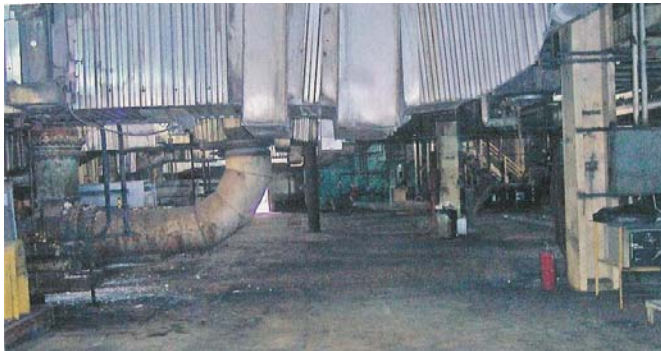
Original metal box-fold expansion joint lagged with insulation

The utility had replaced their 25 year old original hot air pulverizer metal expansion joints in favor of a less expensive fabric joint.

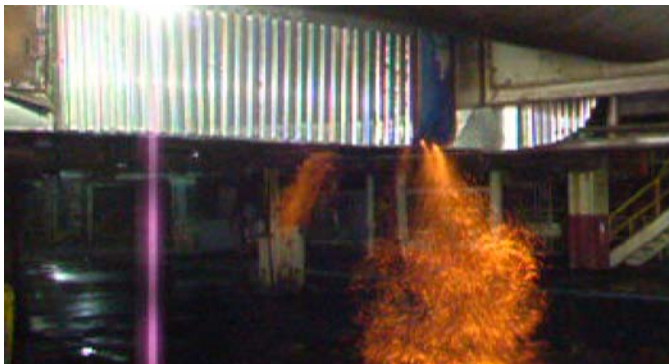
Coal dust igniting through tears in the fabric expansion joint

Although fabric expansion joints are common in other ducting systems, coal dust explosions in the pulverizer ducting happen more than they should – especially in horizontal ducts. The designs of the original metal expansion joints were robust and held up well under such harsh conditions.

Due to their inability to handle high temperatures, the fabric belts cannot be lagged over which further increases the exposure of personnel to hot gases if ruptured.

The utility quickly decided to go back to the metal expansion joint design that had served them well for many years.

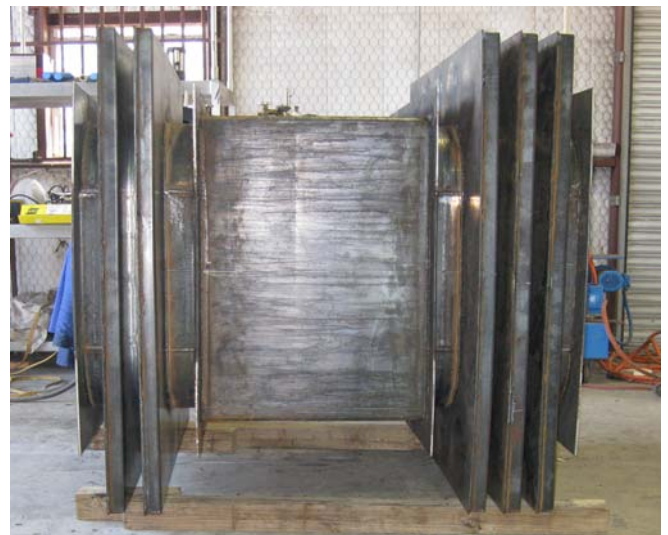
The box-fold style is bullet-proof and time tested

Oakridge Bellows supplied an exact duplicate of the original box-fold bellows. This style, with its deep convolution design, is both highly flexible and rugged.
