### Replacement Bellows and Expansion Joints in Gas Turbine Repairs

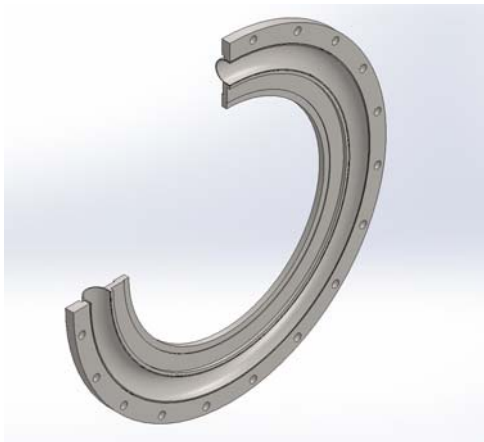
Replacement bellows for hard to find parts such as this expansion ring that came off of a Westinghouse turbine.

New and rebuilt services for leaking parts

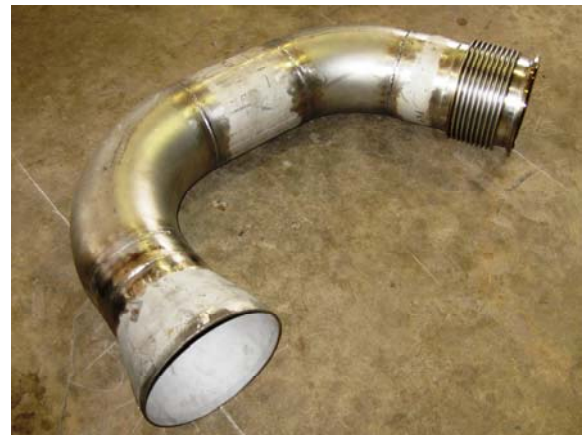
Small gas turbine exhaust piping with bellows
