The Bellows Bottom Line

Practical advice on expansion joints

This month - **When weld repairs work - and we don't know why**

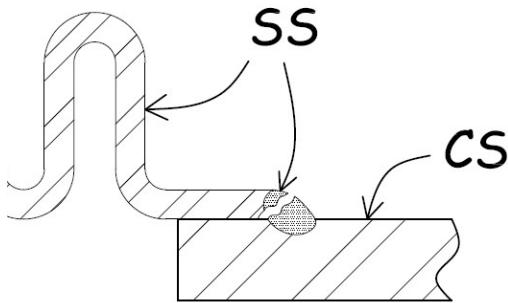
Got a call years ago from a power plant that kept shutting down to weld repair a bellows attachment weld on their old Westinghouse steam cross-over expansion joint – their weld repairs held up less than a year.

I was not confident as to why the cracks were chronic, and therefore unsure if this would solve the problem.

At the operating temperature of that steam system, calculations show there is no excessive thermal growth stresses between CS and SS. And yet there was cracking.

The original cracking could be explained by poor fit-up combined with excessive vibration – we just don't know.

“*Try using Inco 82 tig wire this time*”, I told them.

We do know that Inco 82 fixed it, and then we all noted it, and then moved on.
